Community Preservation Committee Town of Arlington

CPA Funding - FY2020 Final Application

Community Preservation Committee Request for Funding Rehabilitation of the Whittemore-Robbins Cottage Exterior

Re: Whittemore Robbins Cottage

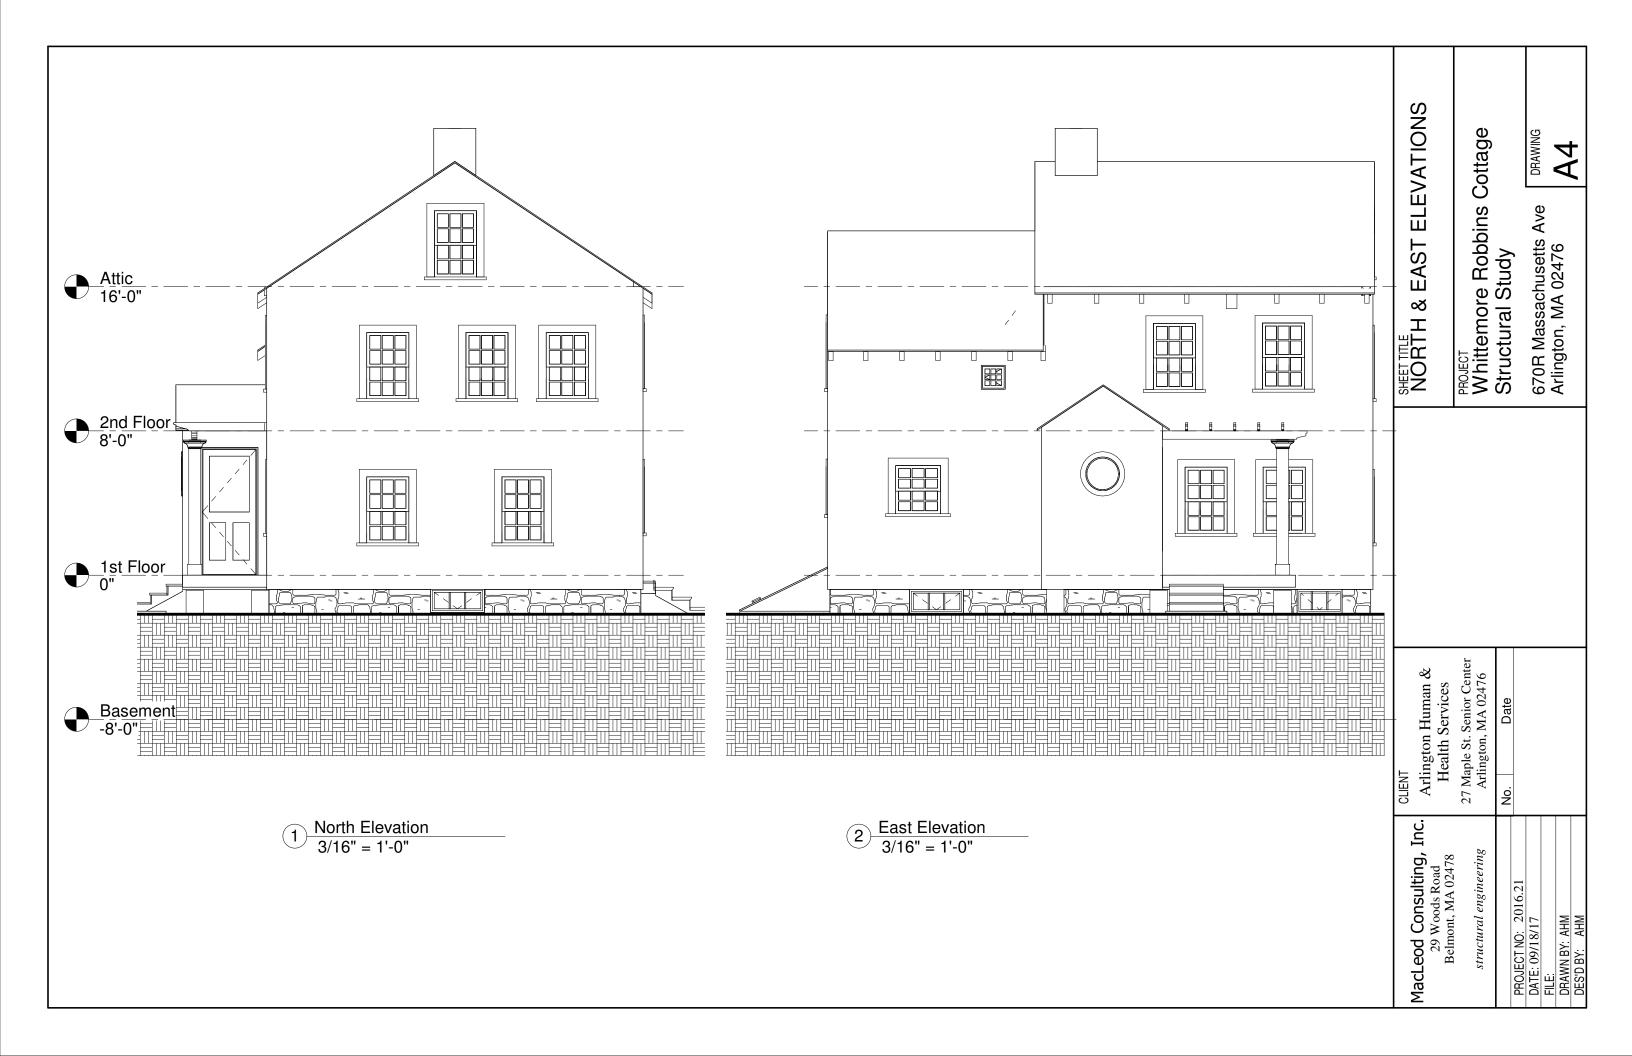
- 1. Chimney supported beams (See sheets S1 & S2). The one chimney is located between the main block of the cottage and the ell. At the first, second, and attic levels a pair of wood beams frame into the chimney. It has been a long-standing code requirement to have a two-inch space between framing and chimneys. The one exception is a qualified chimney liner which permits framing to touch the outside face of the chimney. In this case, the framing is embedded into the chimney, a violation. The support of floor framing at the chimney needs to be reconfigured to isolate the chimney from the framing. The solution will require careful coordination with proposed walls to provide a rational load path up and down the structure.

- 4. Rotted 1st floor beam (See Sheet S1). The beam spanning east-west and supported on the north side of the chimney is rotted at the west foundation wall. Replace this span.

- 5. Anomalous joist framing (See Sheet S1). At the north end of the first floor, the first-floor framing appears to be infill framing as though this may have been a former stair opening. The purpose is not clear. Remove this framing and replace with joists comparable to those on either side.

- 6. Shore by chimney (See Sheet S1). Remove this shore after the floor is resupported and isolated from the chimney.
- 7. Vestibule settlement (See Sheet S1). The vestibule has settled about two inches. Most likely the present piers were terminated above the basement excavation cut line. Replace the existing piers with round concrete piers carried down to undisturbed soil at least four feet below grade

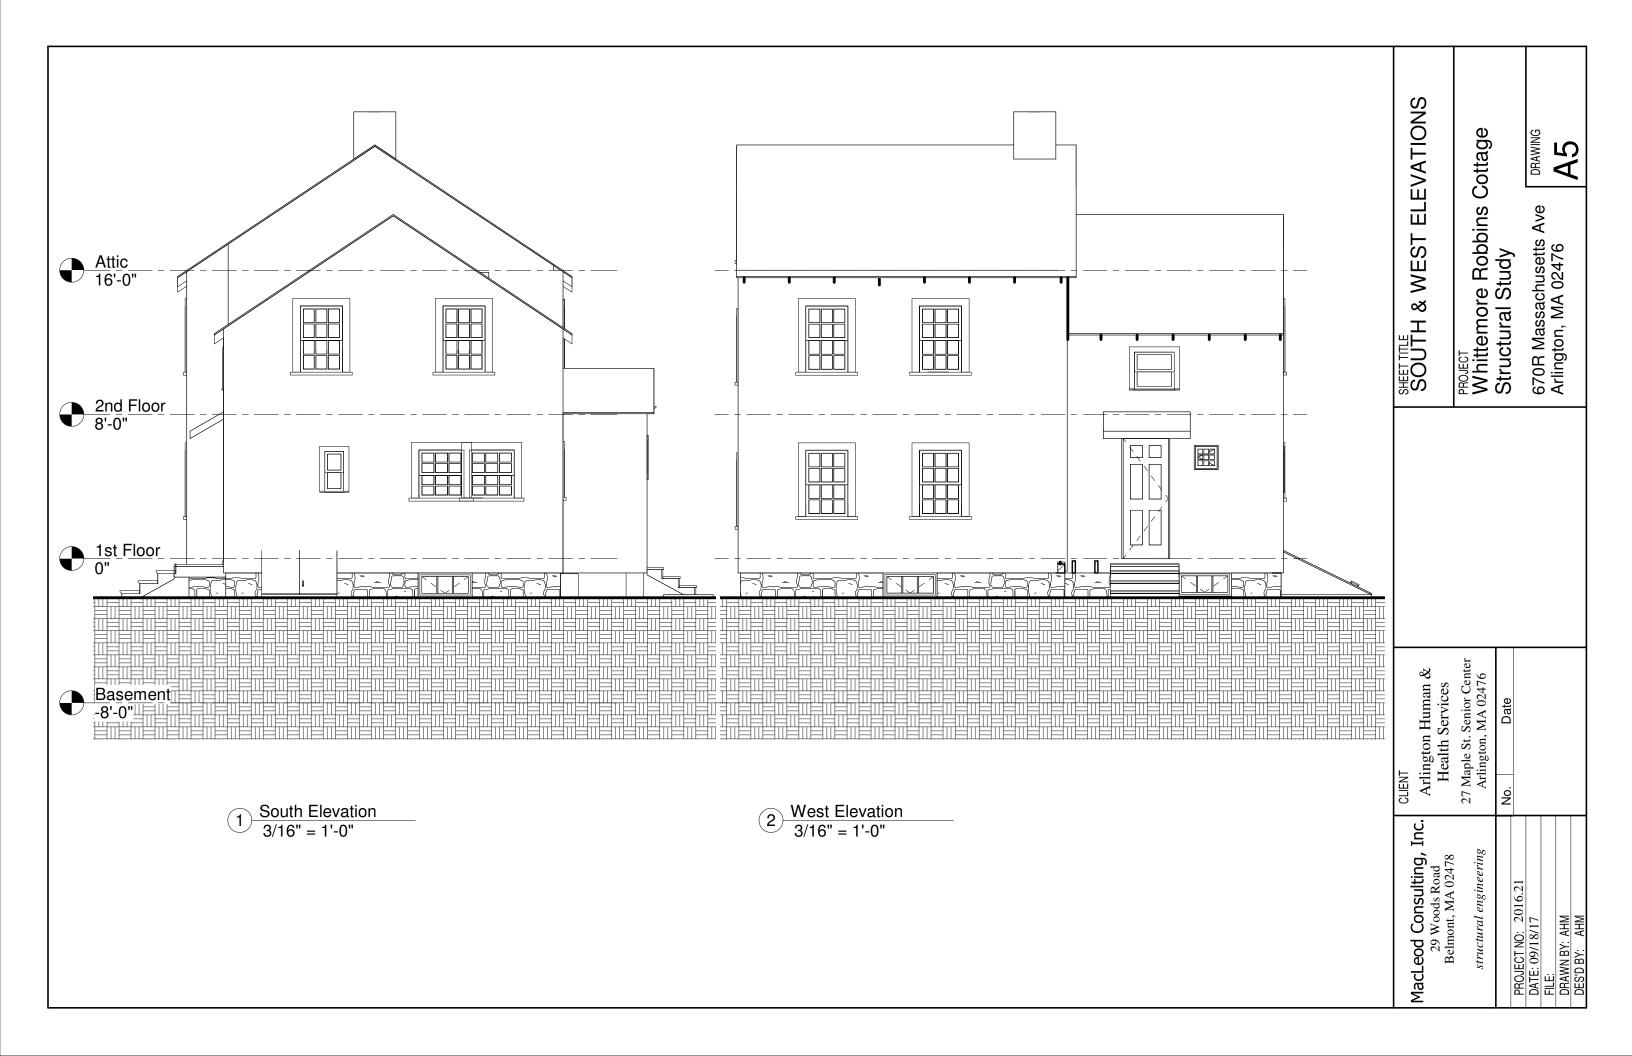
- 3. Undersized post (See Sheet S2). The 4x4 wood post over the 12-inch square brick column has 80 percent of the required capacity. Replace it with a stronger wood post.

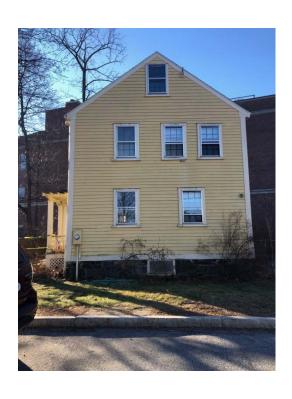
1. View of Cottage from parking lot

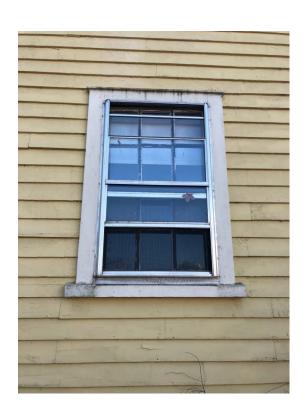
2. Close up photo of window

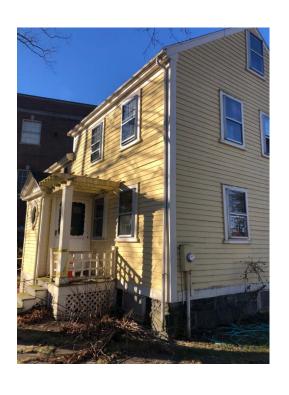
3. View of east entrance from parking lot

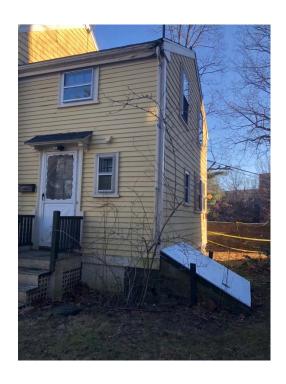
4. View of back of building

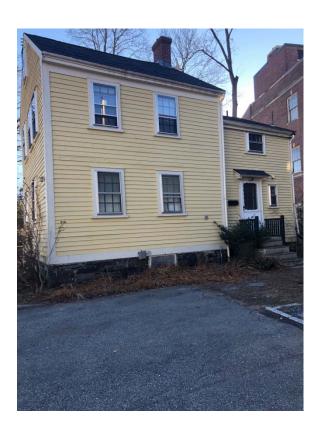
5. View of west entrance from parking lot
